# Manhole Inspection Summary

Manhole # S69S\_\_025MH

Insp Date: **4/9/08 10:56 AM**

**Location** Address: **6502 Brown Ave.**

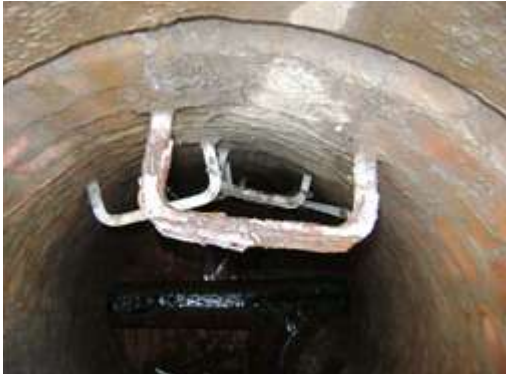
Defect 3

Condition: ☐ Sound ☐ Cracked ☐ Root Intrusion ☒ **Loose Brick** ☒ **Deteriorated**

Count: **5** Missing: **0** ☒ **Corroded**

CORROSION of chimney and steps.

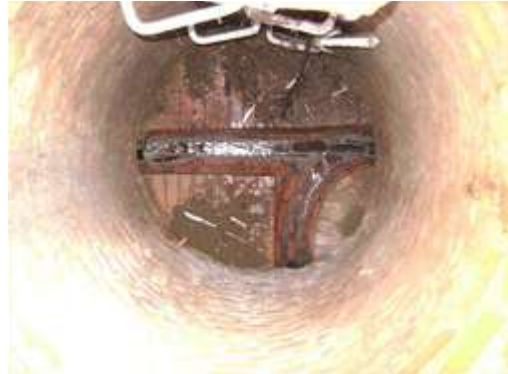
Defect 1

OFFSET JUNCTION and DEBRIS on bench

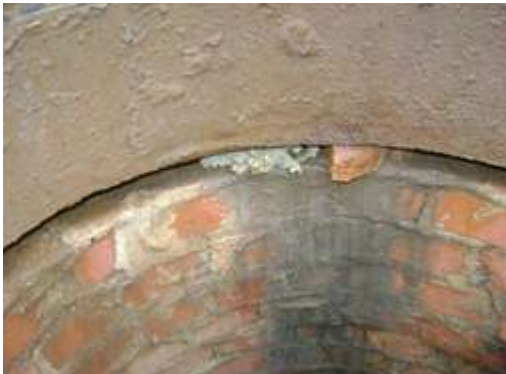
Defect 4

Infiltration: ☐ None ☒ **Joint** ☐ Cracks ☐ Mortar ☐ Roots ☐ Wall

INFILTRATION from joint between chimney and frame.

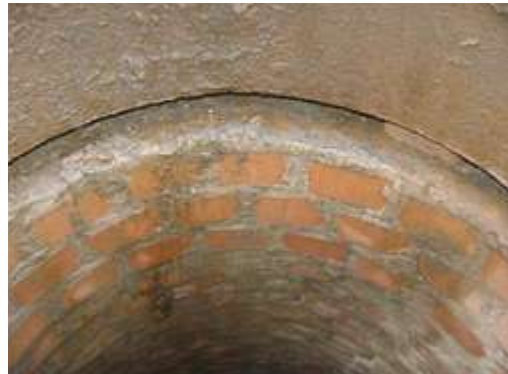
Defect 2

Offset: **1** (in.)

FRAME OFFSET

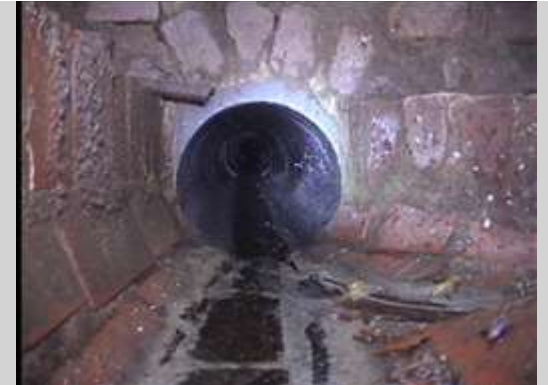
12 O'Clock Outflow

Pipe Height: **8.4** (in.) Rod and Bar (Angled)  
Pipe Material: **Clay** ☐ Pipe Lined  
Invert Depth: **9.29** (ft.) Flow Characteristics: **Slow**  
Deposits: ☒ None ☐ Mud ☐ Sludge ☐ Debris ☐ Grease  
Silt Depth: (in.) Deposits Extent:  
Infiltration: **None** Pipe Seal Cond: **Sound**

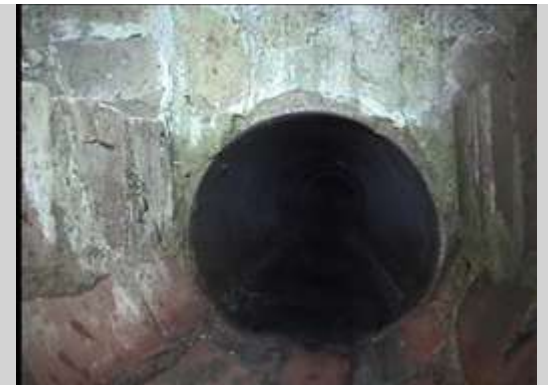
3 O'Clock Inflow

Pipe Height: **8.4** (in.) Rod and Bar (Angled)  
Pipe Material: **Clay** ☐ Pipe Lined  
Invert Depth: **9.21** (ft.) Flow Characteristics: **Slow**  
Deposits: ☒ None ☐ Mud ☐ Sludge ☐ Debris ☐ Grease  
Silt Depth: (in.) Deposits Extent:  
Infiltration: **None** Pipe Seal Cond: **Sound**

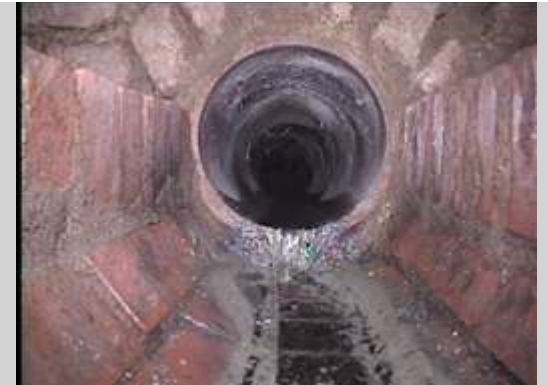
6 O'Clock Inflow

Pipe Height: **8.4** (in.) Rod and Bar (Angled)

Invert Depth: **8.83** (ft.) Flow Characteristics: **Slow**

Infiltration: **None** Pipe Seal Cond: **Sound**
